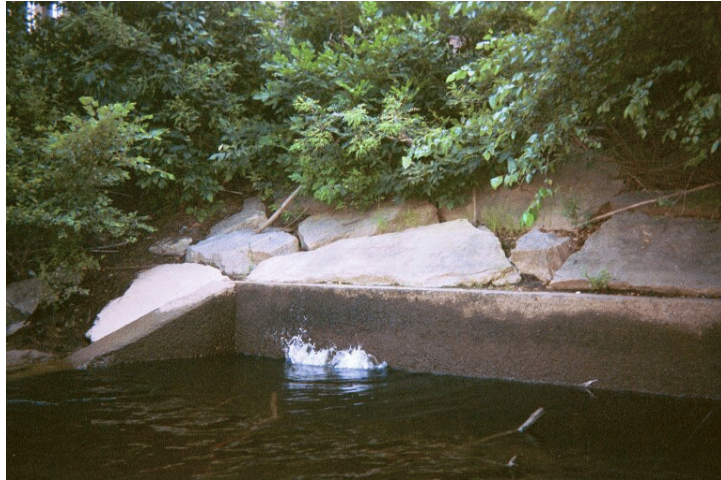
**Pipe # 12:**

Approximately 10' wide concrete culvert. Fully submerged. *Flowing, unable to estimate flow. Discharge has a strong odor, and contains fine solids and large bubbles.* Only the downstream half of the culvert is flowing. Located behind the Ayer Mill Complex on Union Street.

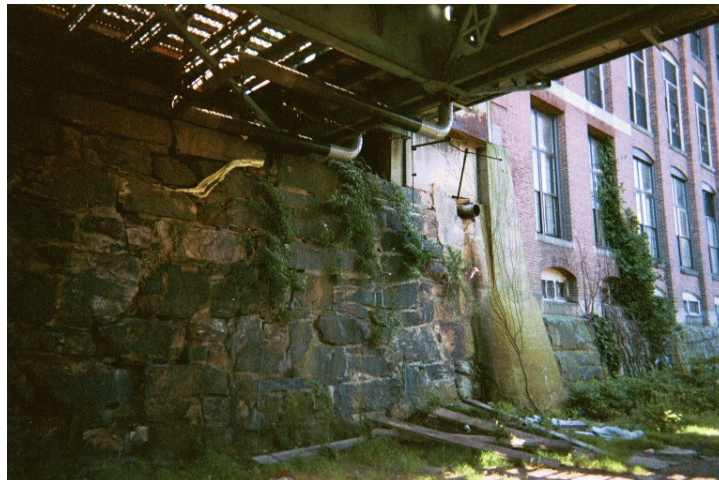
**Pipe # 13:**

Approximately 12" diameter iron pipe. Located in the foundation for the Ayer Mill Complex, near the Duck Bridge (Union Street). No flow.

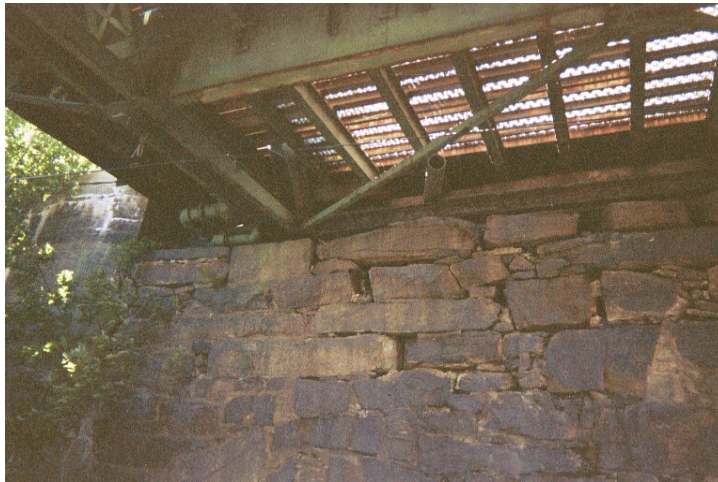
Pipe # 14:	Approximately 8" diameter iron pipe. Located directly underneath the decking for Duck Bridge (Union Street), in the south abutment. No flow.
------------	--

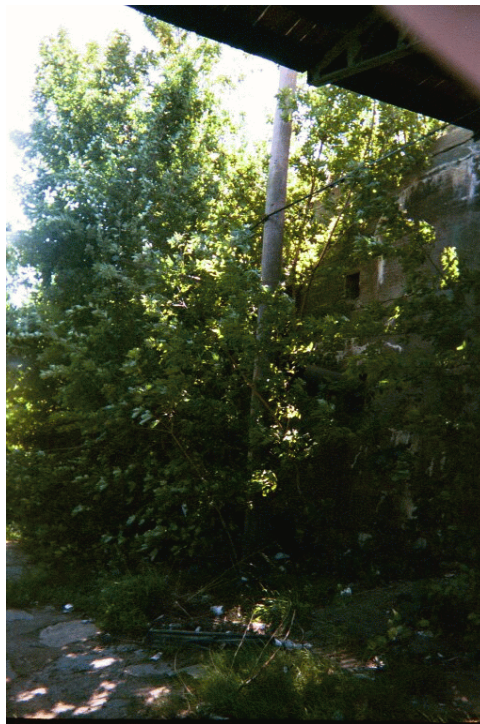
Pipe # 15:	Approximately 12" wide square concrete culvert. Located in a concrete wall, adjacent to the south abutment for Duck Bridge (Union Street). No flow.
------------	---

Pipe # 16:	Approximately 24" diameter iron pipe. Located approximately 4' below Pipe # 15. No flow.
------------	--

Pipe # 17:	Approximately 12" wide square concrete culvert. Located approximately 4' below Pipe # 16. No flow.
------------	--

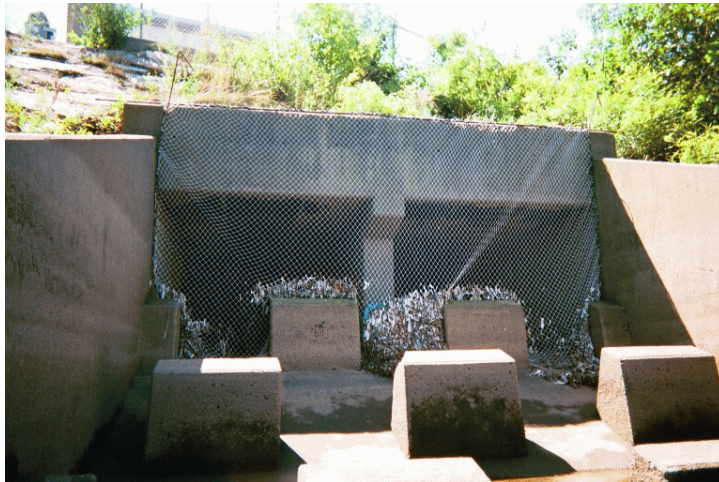
Pipe # 18:	Approximately 15' wide rectangular concrete culvert covered with netting. Paper and plastic debris caught throughout netting. Baffle piers located in front of the culvert. No flow.
------------	--

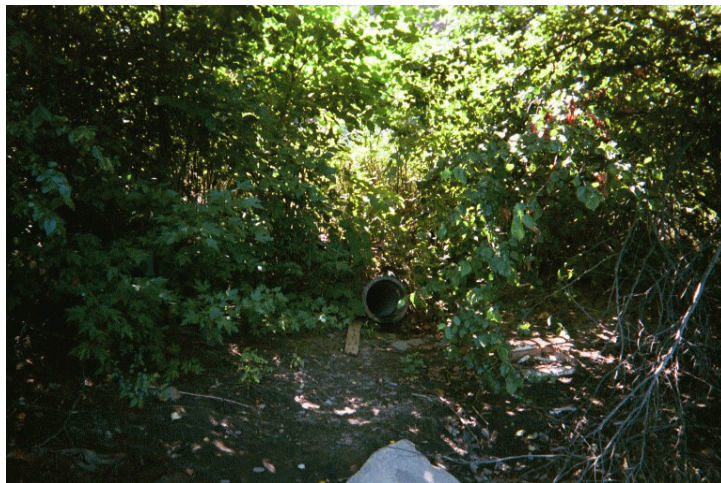
Pipe # 19:	Approximately 12" diameter iron pipe. Located approximately 6' up the embankment, behind a brick mill building with two tall brick stacks. No flow.
------------	---

Pipe # 20:	Approximately 4" diameter iron pipe. Located to the right of Pipe # 19. No flow.
------------	--

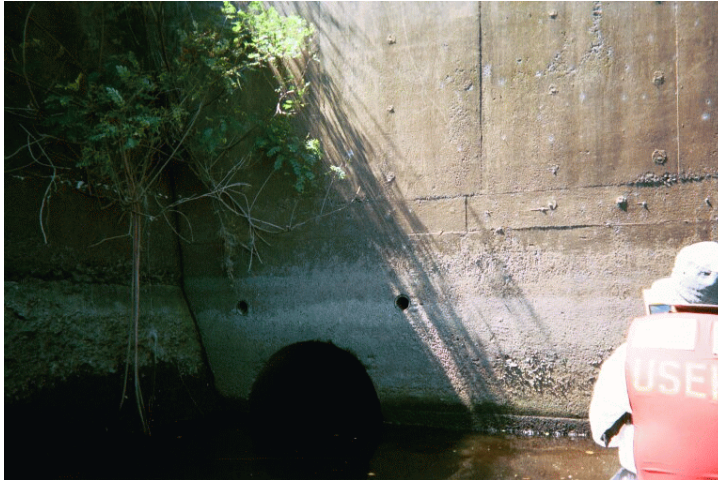
Pipe # 21:	Approximately 36" diameter concrete pipe. Located in concrete wall at end of a brick mill building with no roof, near the confluence of the Shawsheen River. This mill building is located behind the 360 Merrimack Street mill complex. No flow.
Pipe # 22:	Two (2) approximately 2" diameter clay pipes located approximately 1' above Pipe # 21. No flow.

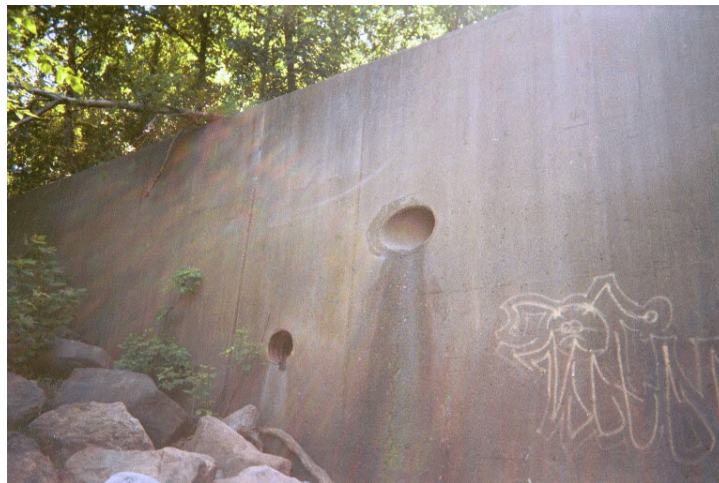
Pipe # 23:	Approximately 14" diameter concrete pipe. Located in a wall for the Marston Street/Interstate 495 overpass. No flow.
Pipe # 24:	Approximately 12" diameter corrugated metal pipe. Located in wall for the Marston Street/Interstate 495 Overpass. No flow.
